Thea Foss and Wheeler-Osgood Waterways Long Term Monitoring Plan

Preliminary Findings Memorandum – Subtidal Cap Hydrographic Survey – Year 12

REVISED PRELIMINARY FINDINGS MEMORANDUM SUBTIDAL CAP HYDROGRAPHIC SURVEY YEAR 12 MONITORING

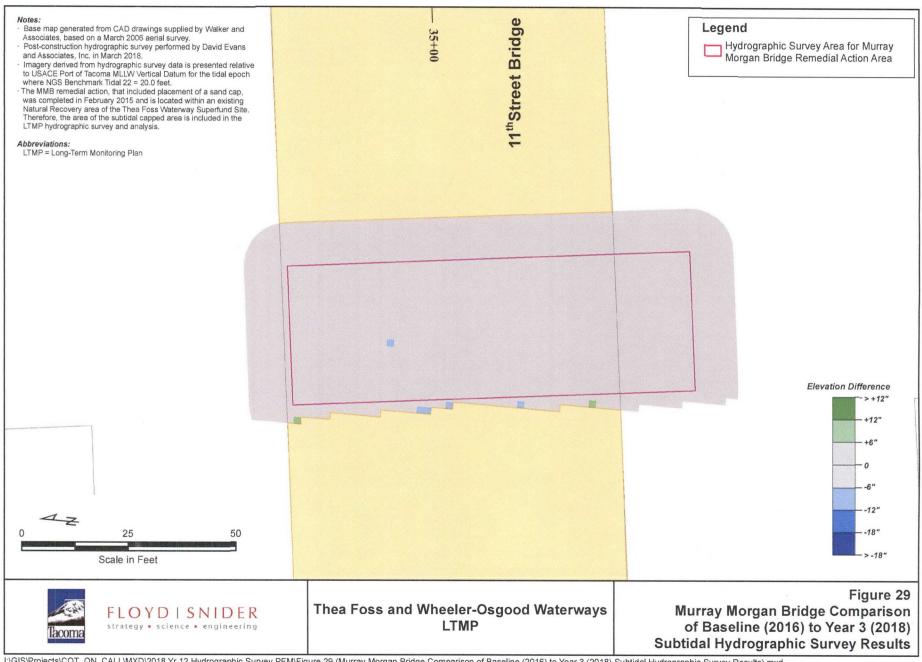
Figure 28
Murray Morgan Bridge Comparison of
2015 and 2016 Subtidal Hydrographic
Survey Results

The Year 3 (2018) capped surface elevation for the channel sand cap area is generally within six inches of the baseline (Year 1) surface elevation, which is within the allowable accuracy of the survey equipment (Figures 20 and 29). There is one very small (less than 7 sf) and localized area where a decrease in cap elevation greater than six inches but less than one foot was observed. This decrease is in an area where an increase in cap elevation was previously observed between 2015 and 2016 (Figure 28), therefore, no response actions are warranted.

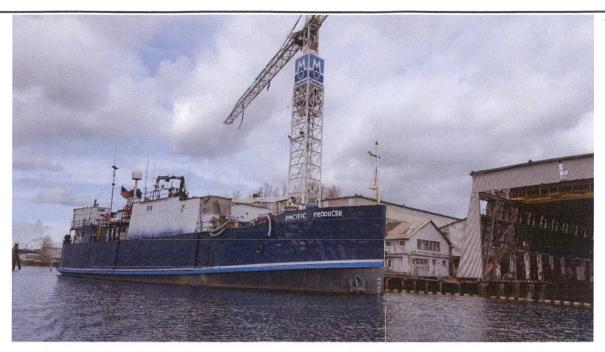
Photograph 1. View of Vessel Moored in Front of Remedial Area 14 (Facing North/Northeast in Thea Foss Waterway)

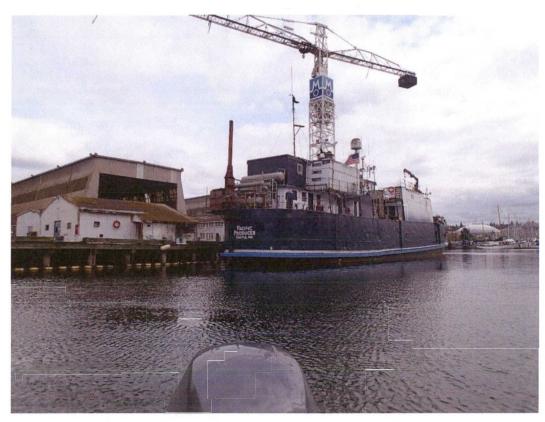
Photograph 2. View of Vessel Moored in Front of Remedial Area 14 (Facing South/Southeast in Thea Foss Waterway)
